Casa Building Inspections LLC

Report #: 505 Liberty Ave, Endicott

505 Liberty Ave

Endicott, N.Y. 13760

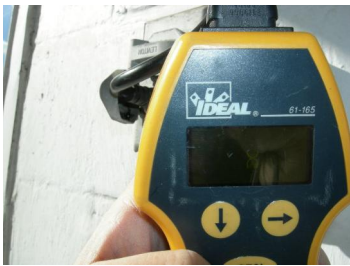
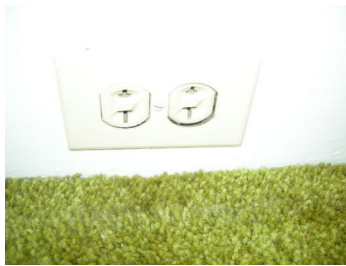
Wiring

Recommend GFCI protection to kitchen,bath and exterior outlets.

Multiple ungrounded outlets noted throughout the structure.

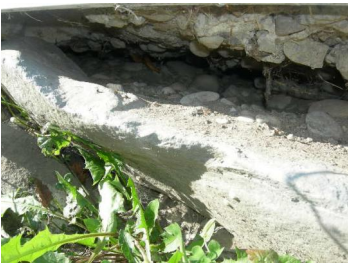
Comments

Recommend repair of eroding soil under rear of garage slab.

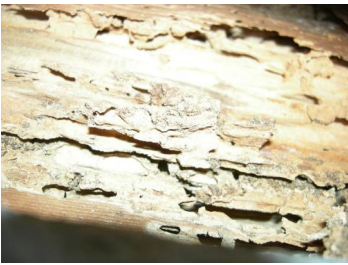
Decks/porch

Comments: The front wooden section of the front porch has some deteriorated wood from wood destroying insects/termite. Recommend further inspection from a qualified exterminator.(2)(3)**07. Fences & Gates**

Deteriorated wood from termite noted at front porch.

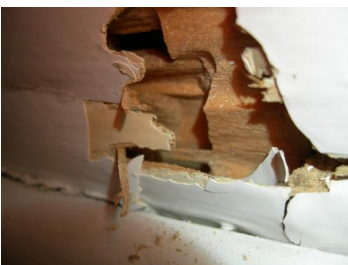
Floors

Recommend repairs to deterioration from wood destroying insects.

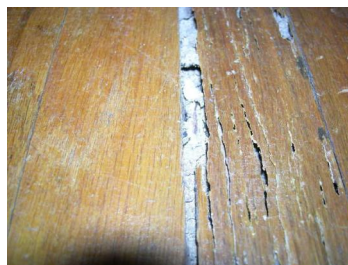
Floors

Recommend repair from wood destroying insect damage.

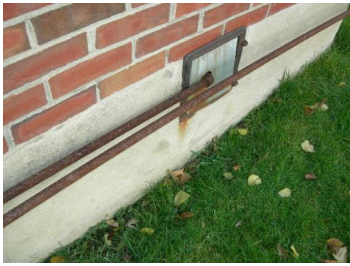
Fuel system

Comments: The fuel lines were not corrosion-proofed. (2)

Recommend fuel lines be protected from corrosion.

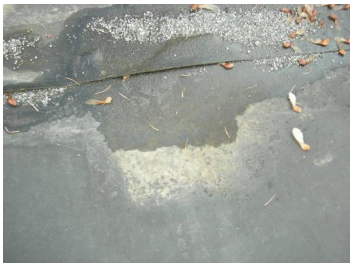
Low slope

Recommend sealing any gaps or separations in material.

Comments: Typical maintenance is recommended to the flat roof. This usually consist of covering all exposed areas with additional aggregate material, repairing any open seams, repairing all /any cracks in the flashing and roofing material, and periodic inspections.
